Highway Factors Photographs 1 through 18

Fort Worth, TX

HWY21FH005

Specialist's Factual Report By Kyle Garner

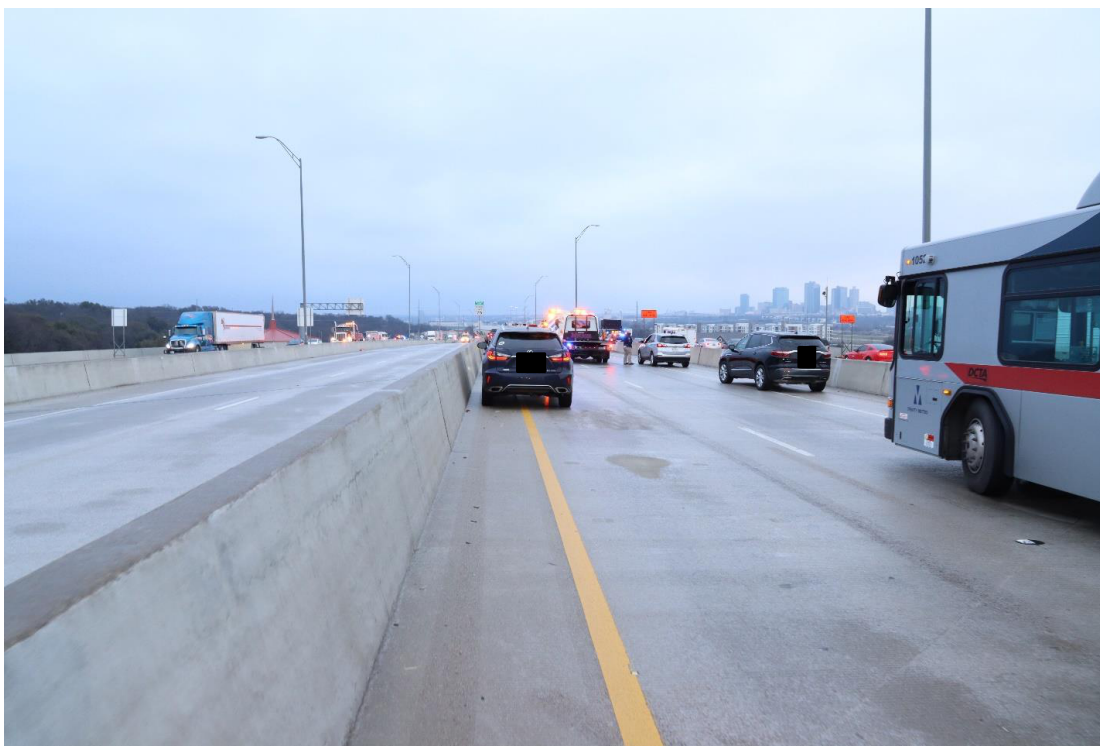
Highway Factors Photo 1 - View of I-35W southbound toll lanes standing on the left paved shoulder immediately north of the crash scene illustrating patches of ice on the roadway surface and top of the concrete barrier separating the I-35W southbound toll lanes and I-35W northbound toll lanes with the downtown Fort Worth skyline shown in the background looking to the south (Source: Fort Worth Police Department. Photo taken on February 11, 2021, at approximately 7:31 a.m.)

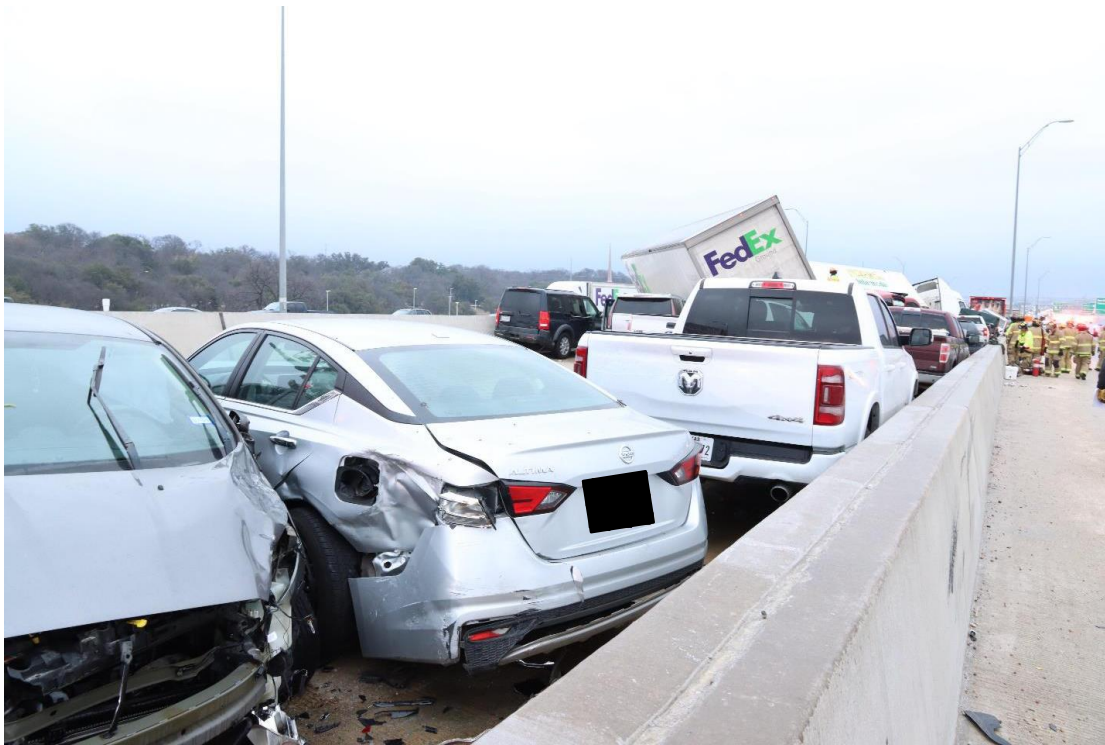
Highway Factors Photo 4 – View of damaged vehicles at the northern end of the I-35W southbound toll lanes crash scene standing on the left paved shoulder of the I-35W southbound general use lanes looking to the southeast (Source: Fort Worth Police Department. Photo taken on February 11, 2021, at approximately 7:35 a.m.)

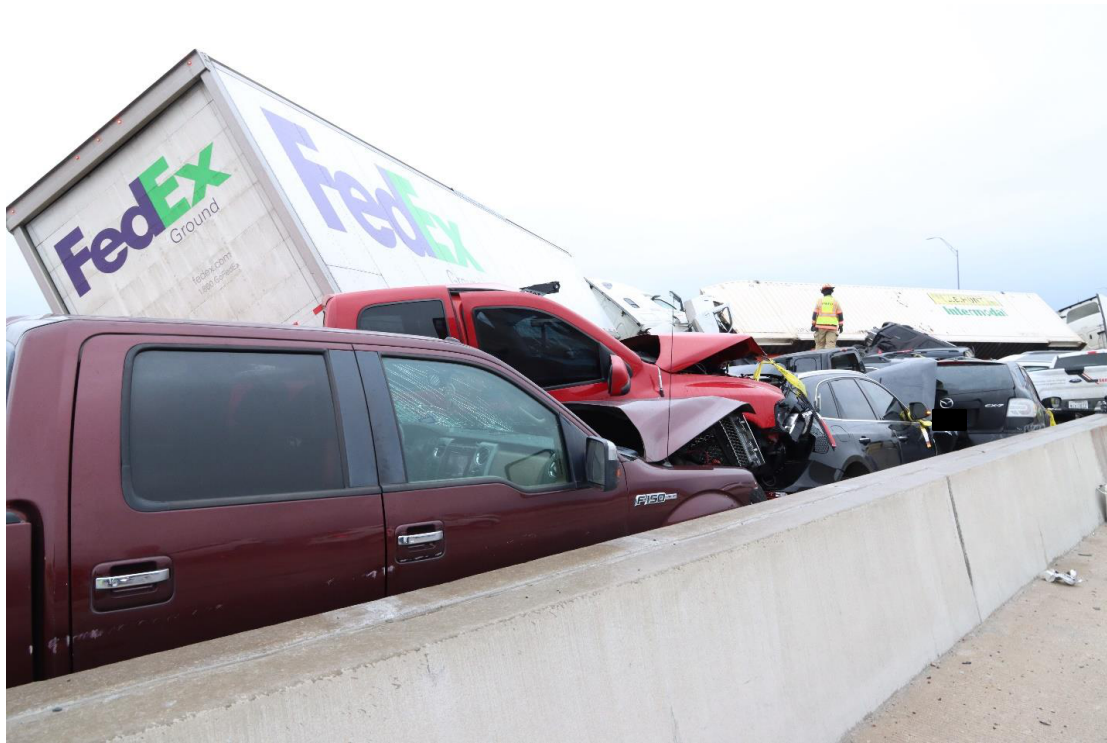
Highway Factors Photo 5 – Another view of damaged vehicles at the northern end of the I-35W southbound toll lanes crash scene standing on the left paved shoulder of the I-35W southbound general use lanes looking to the southeast (Source: Fort Worth Police Department. Photo taken on February 11, 2021, at approximately 7:35 a.m.)

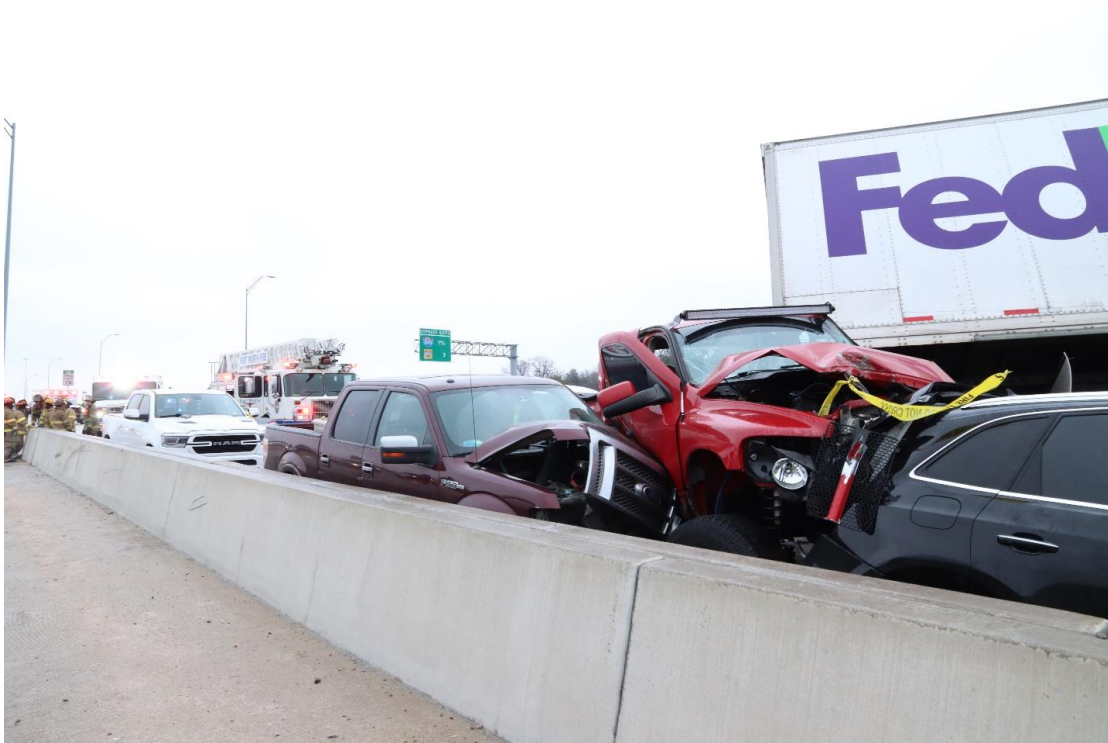
Highway Factors Photo 6 – View of damaged vehicles at the northern end of the I-35W southbound toll lanes crash scene standing on the left paved shoulder of the I-35W southbound general use lanes looking to the northeast (Source: Fort Worth Police Department. Photo taken on February 11, 2021, at approximately 7:36 a.m.)

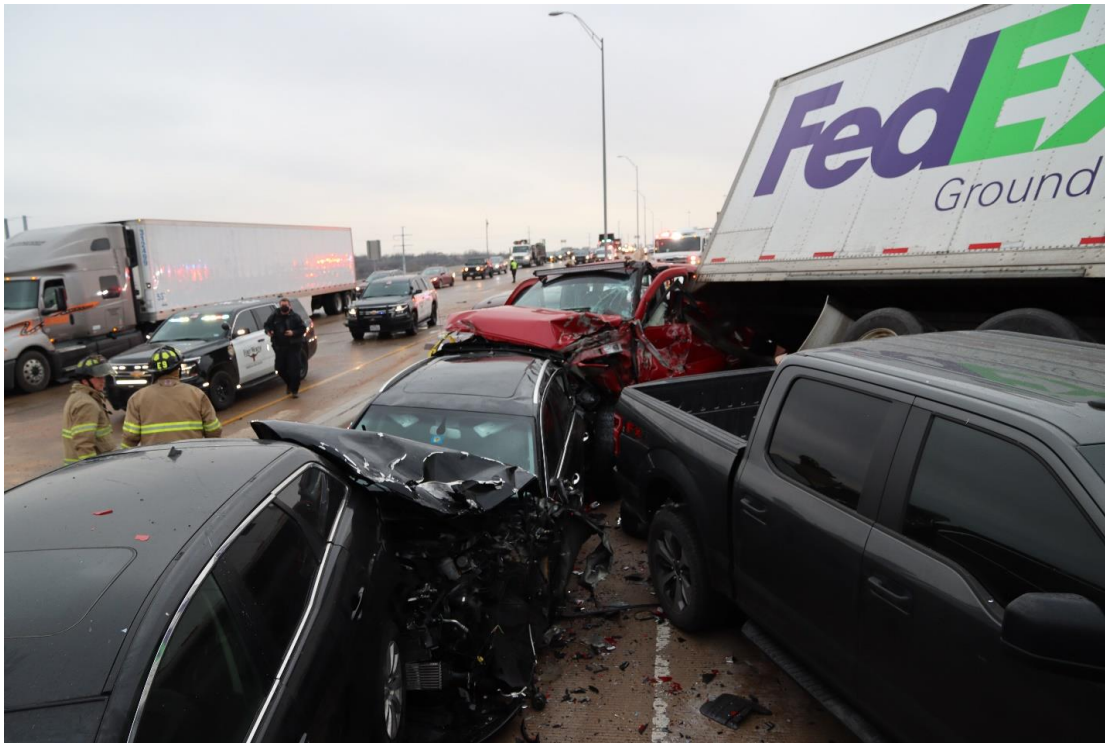
Highway Factors Photo 7 – View of damaged vehicles at the northern end of the I-35W southbound toll lanes crash scene standing above the white pavement marking separating the right paved shoulder from the right travel lane of the I-35W southbound toll lanes looking to the north (Source: Fort Worth Police Department. Photo taken on February 11, 2021, at approximately 7:38 a.m.)

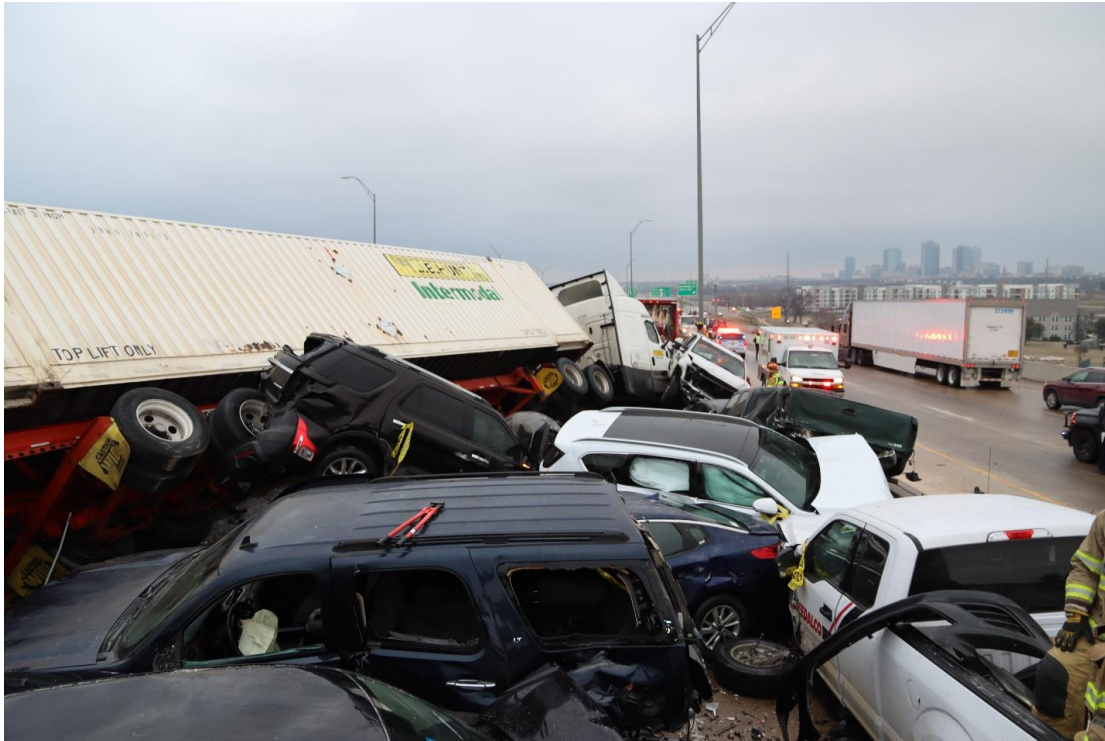
Highway Factors Photo 8 – View of damaged vehicles at the northern end of the I-35W southbound toll lanes crash scene standing above the travel lanes of the I-35W southbound toll lanes looking to the south (Source: Fort Worth Police Department. Photo taken on February 11, 2021, at approximately 7:39 a.m.)

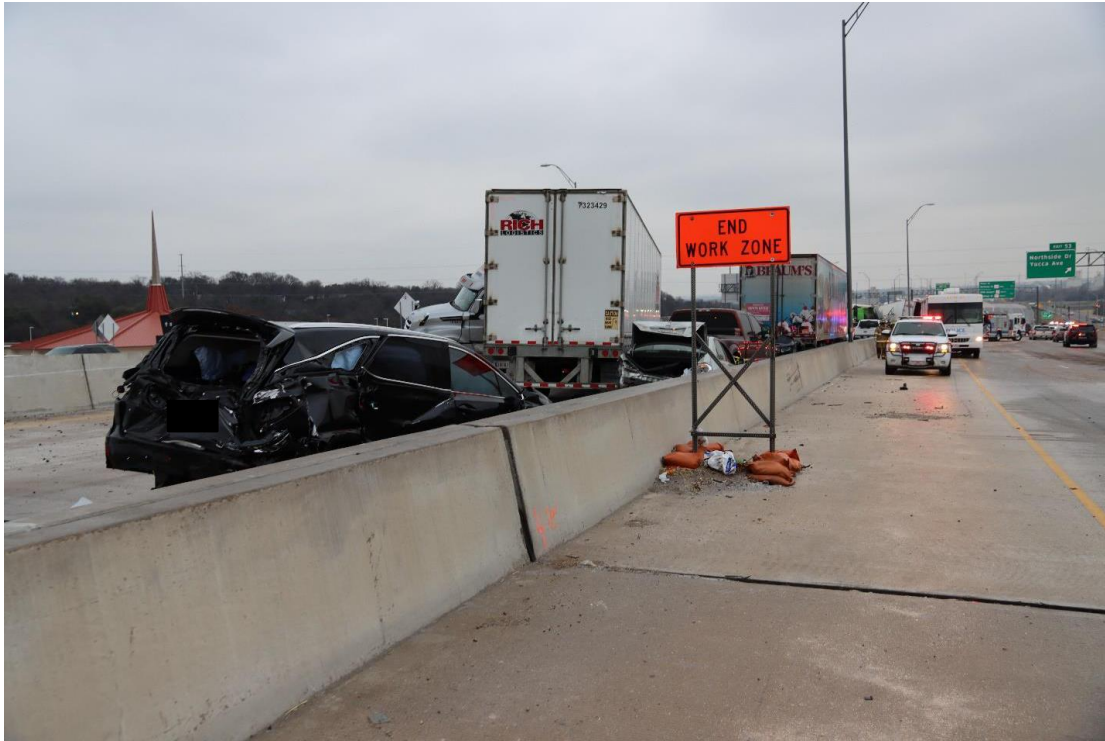
Highway Factors Photo 9 – View of damaged vehicles at the midsection of the I-35W southbound toll lanes crash scene standing on the left paved shoulder of the I-35W southbound general use lanes looking to the south (Source: Fort Worth Police Department. Photo taken on February 11, 2021, at approximately 7:50 a.m.)

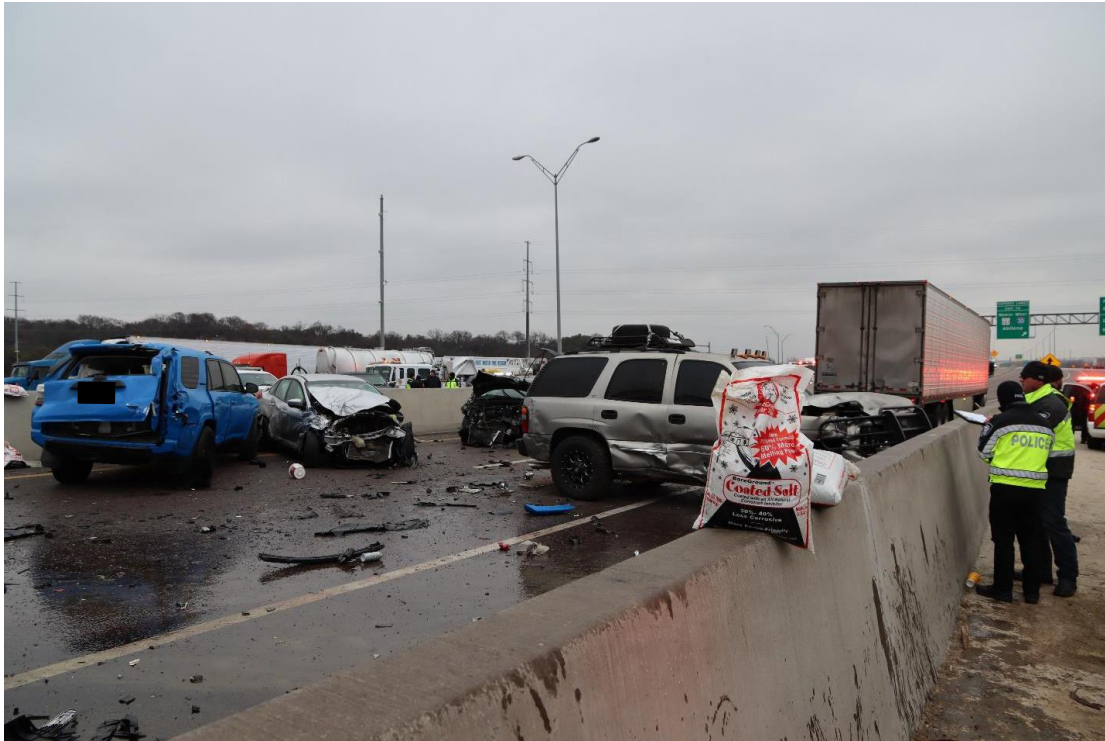
Highway Factors Photo 10 - View of damaged vehicles at the southern end of the I-35W southbound toll lanes crash scene standing on the left paved shoulder of the I-35W southbound general use lanes illustrating bags of coated salt on top of the concrete barrier used by first responders to treat ice on the roadway surface looking to the southeast (Source: Fort Worth Police Department. Photo taken on February 11, 2021, at approximately 8:03 a.m.)

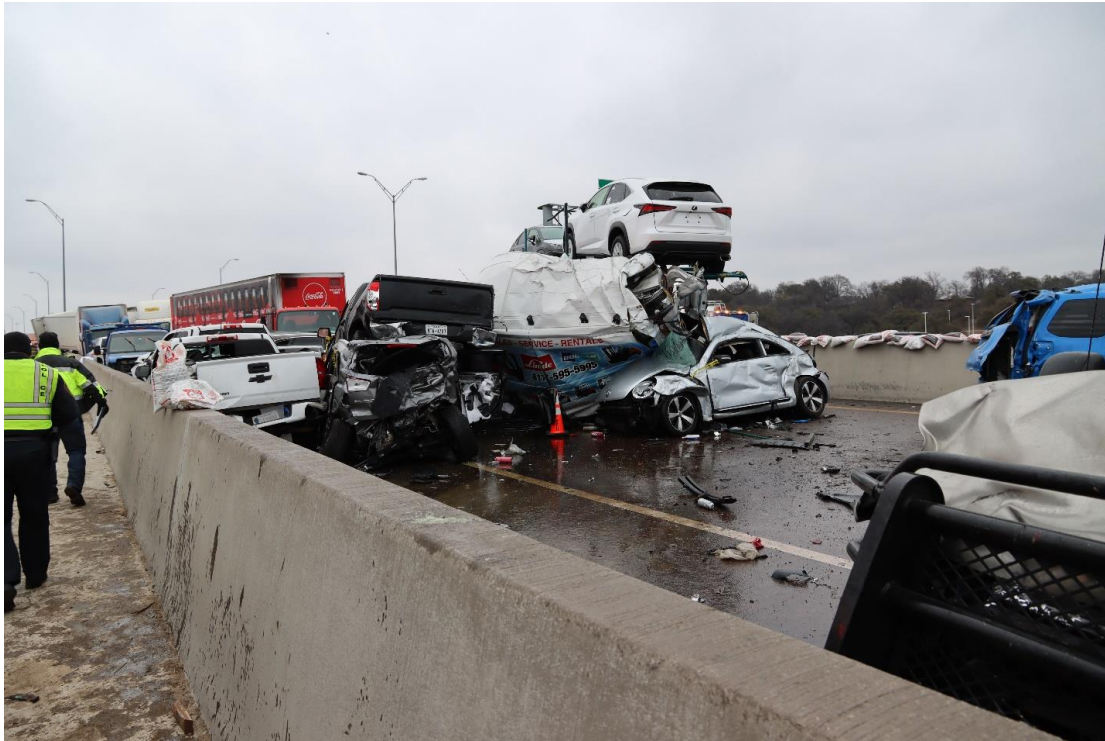
Highway Factors Photo 11 – View of damaged vehicles at the southern end of the I-35W southbound toll lanes crash scene standing on the left paved shoulder of the I-35W southbound general use lanes illustrating bags of coated salt on top of the concrete barrier used by first responders to treat ice on the roadway surface looking to the northeast (Source: Fort Worth Police Department. Photo taken on February 11, 2021, at approximately 8:04 a.m.)

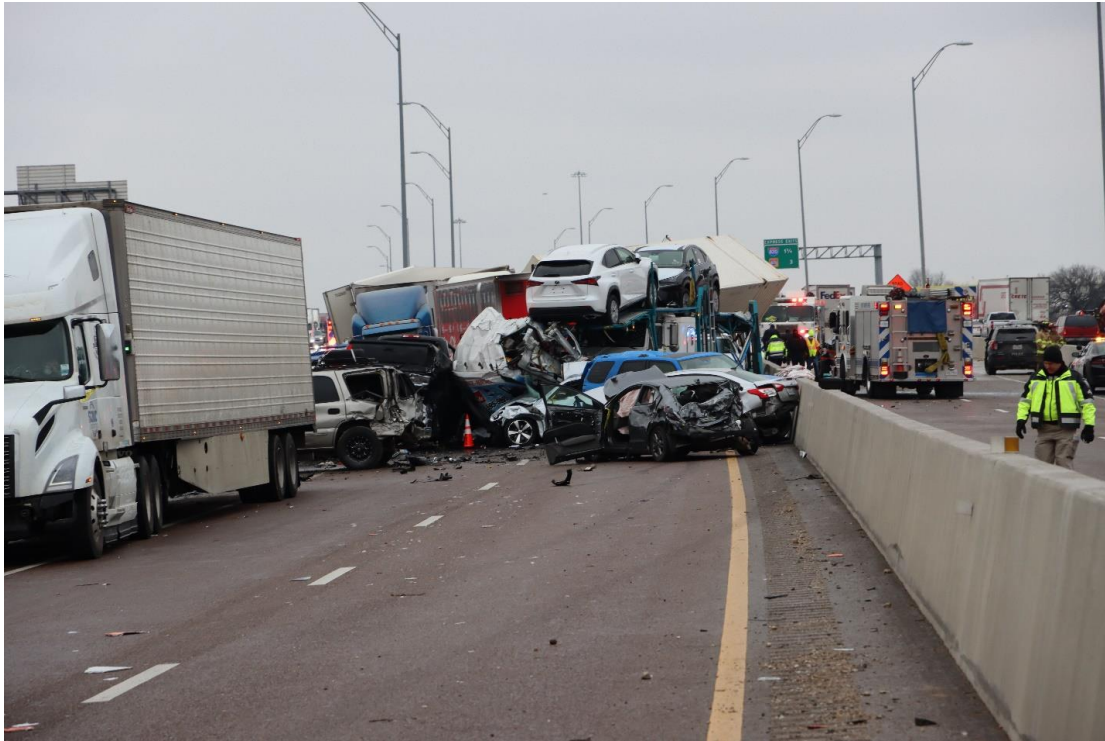
Highway Factors Photo 12 – View of damaged vehicles at the southern end of the I-35W southbound toll lanes crash scene standing on the left paved shoulder of the I-35W southbound toll lanes looking to the north (Source: Fort Worth Police Department. Photo taken on February 11, 2021, at approximately 8:08 a.m.)

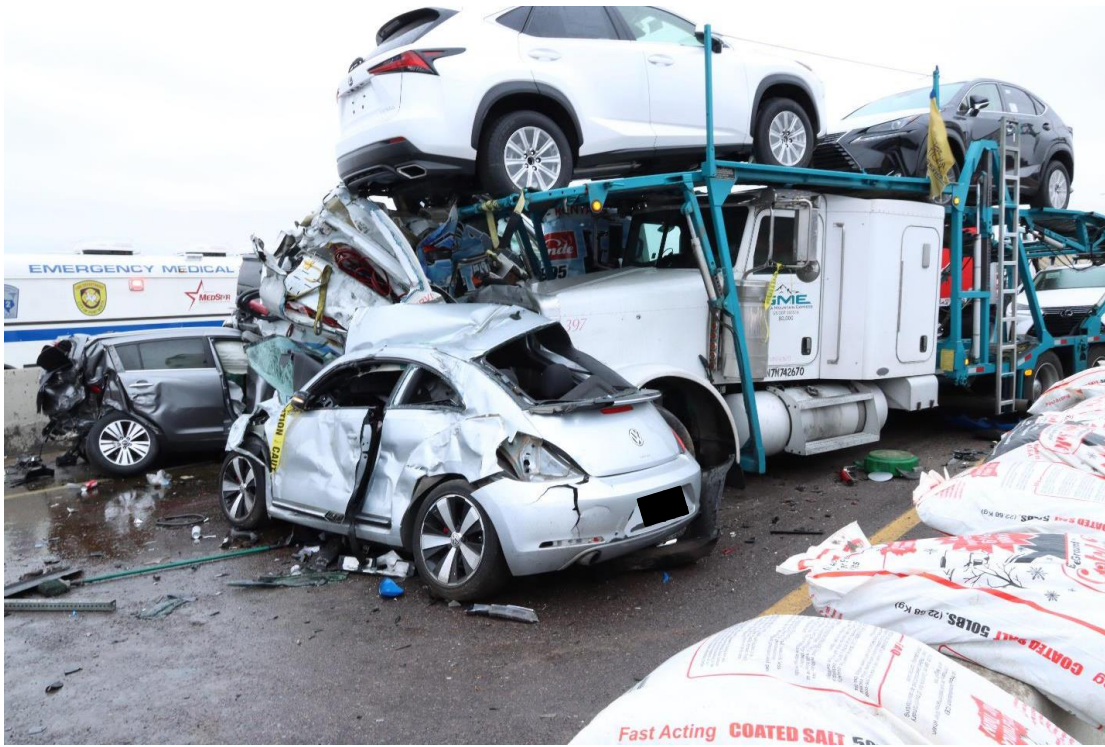
Highway Factors Photo 13 – View of damaged vehicles at the southern end of the I-35W southbound toll lanes crash scene standing on the left paved shoulder of the I-35W northbound toll lanes illustrating bags of coated salt on top of the concrete barrier used by first responders to treat ice on the roadway surface looking to the northwest (Source: Fort Worth Police Department. Photo taken on February 11, 2021, at approximately 8:30 a.m.)

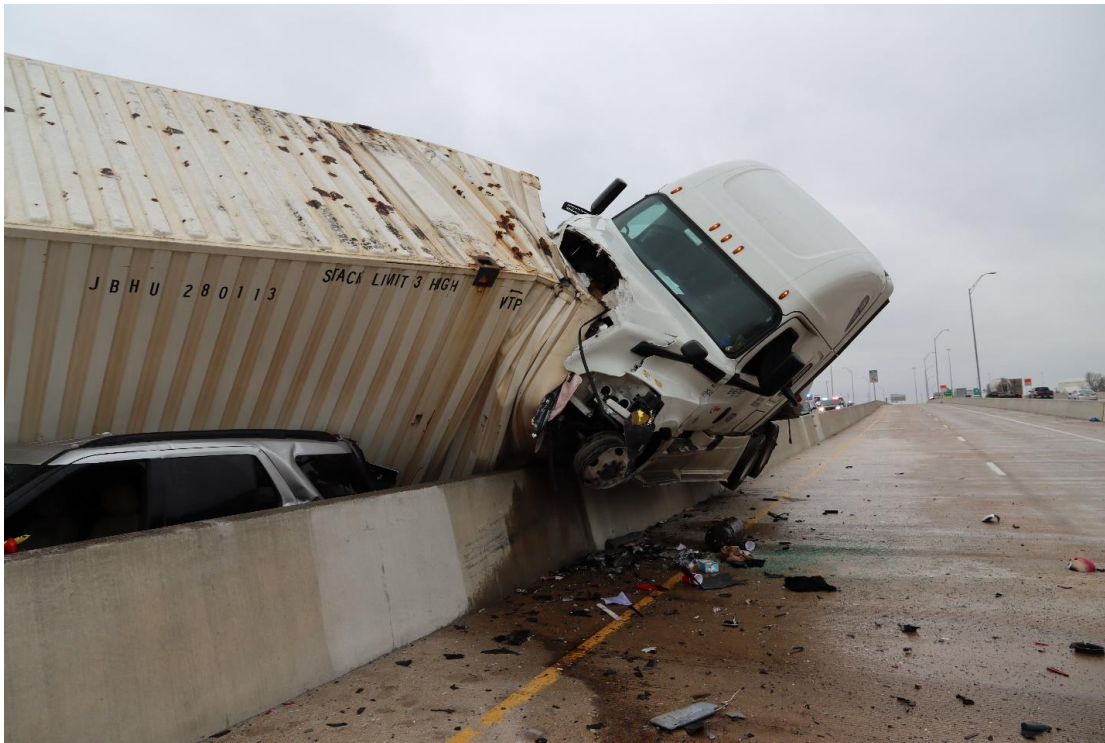
Highway Factors Photo 14 – View of damaged tractor pulling a FedEx trailer hanging over the concrete barrier separating the I-35W southbound toll lanes and I-35W northbound toll lanes standing on the left travel lane of the I-35W northbound toll lanes looking to the north (Source: Fort Worth Police Department. Photo taken on February 11, 2021, at approximately 8:38 a.m.)

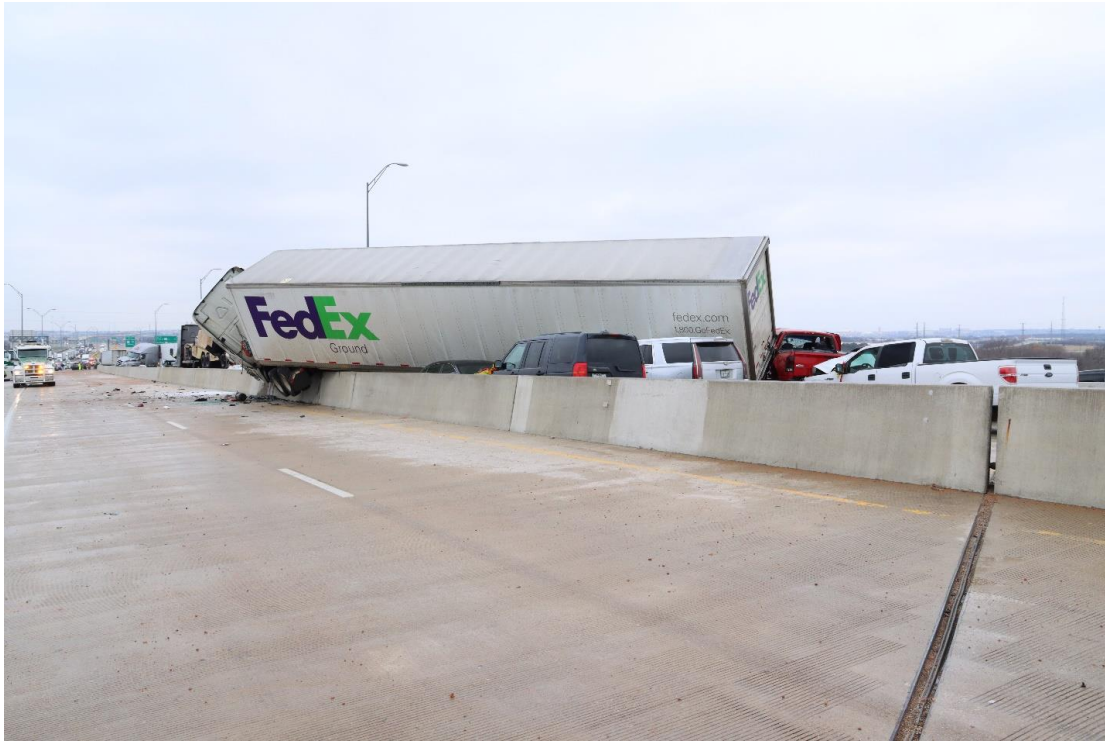
Highway Factors Photo 15 – View of damaged tractor pulling a FedEx trailer hanging over the concrete barrier separating the I-35W southbound toll lanes and I-35W northbound toll lanes standing on the right travel lane of the I-35W northbound toll lanes looking to the south (Source: Fort Worth Police Department. Photo taken on February 11, 2021, at approximately 8:40 a.m.)

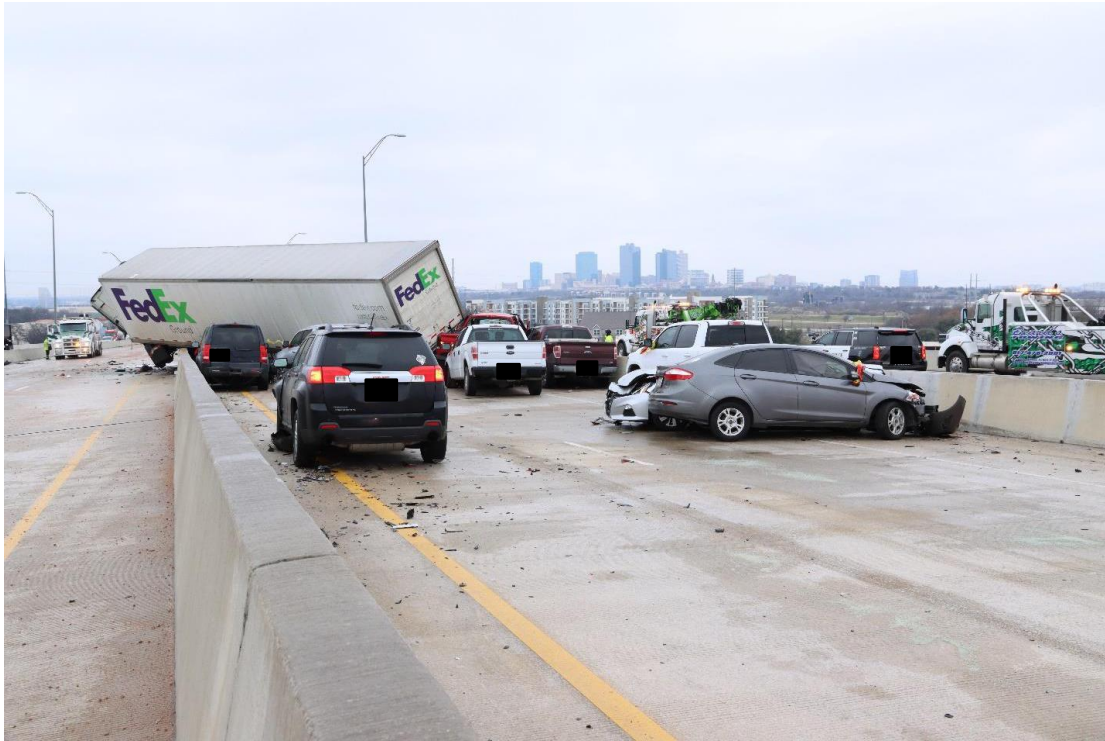
Highway Factors Photo 16 - View of damaged tractor pulling a FedEx trailer hanging over the concrete barrier separating the I-35W southbound toll lanes and I-35W northbound toll lanes standing on the left paved shoulder of the I-35W northbound toll lanes looking to the south (Source: Fort Worth Police Department. Photo taken on February 11, 2021, at approximately 8:40 a.m.)

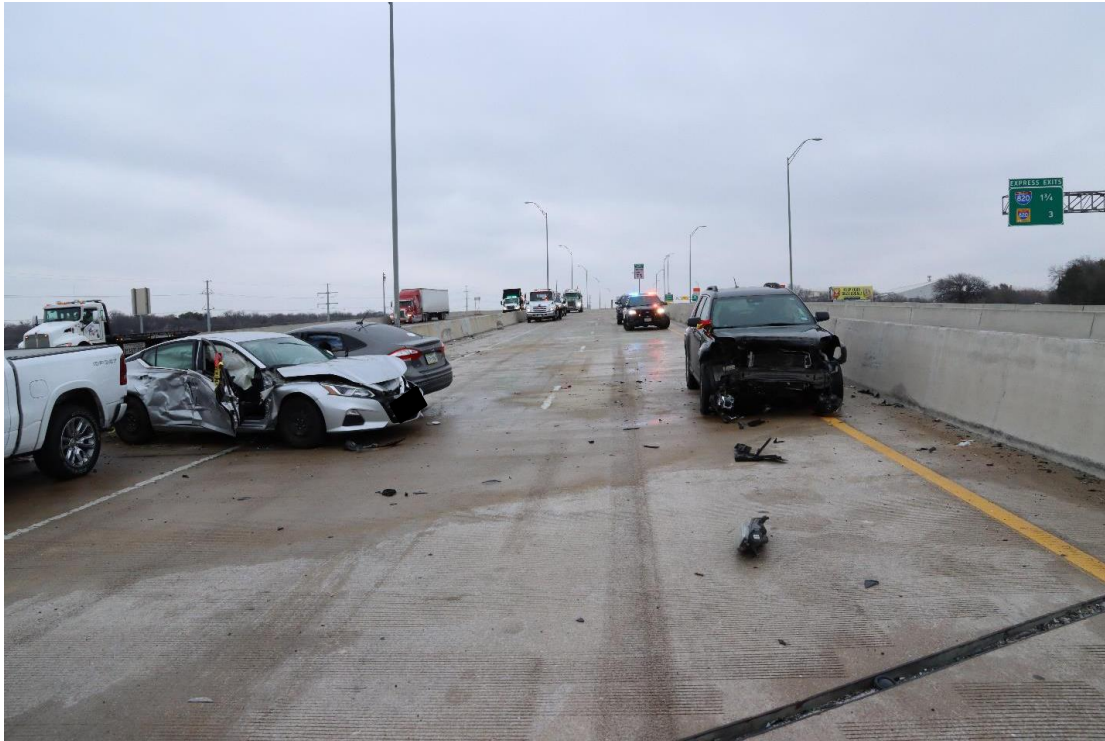
Highway Factors Photo 17 – View of damaged vehicles at the northern end of the I-35W southbound toll lanes crash scene standing on the left travel lane of the I-35W southbound toll lanes looking to the north (Source: Fort Worth Police Department. Photo taken on February 11, 2021, at approximately 8:51 a.m.)

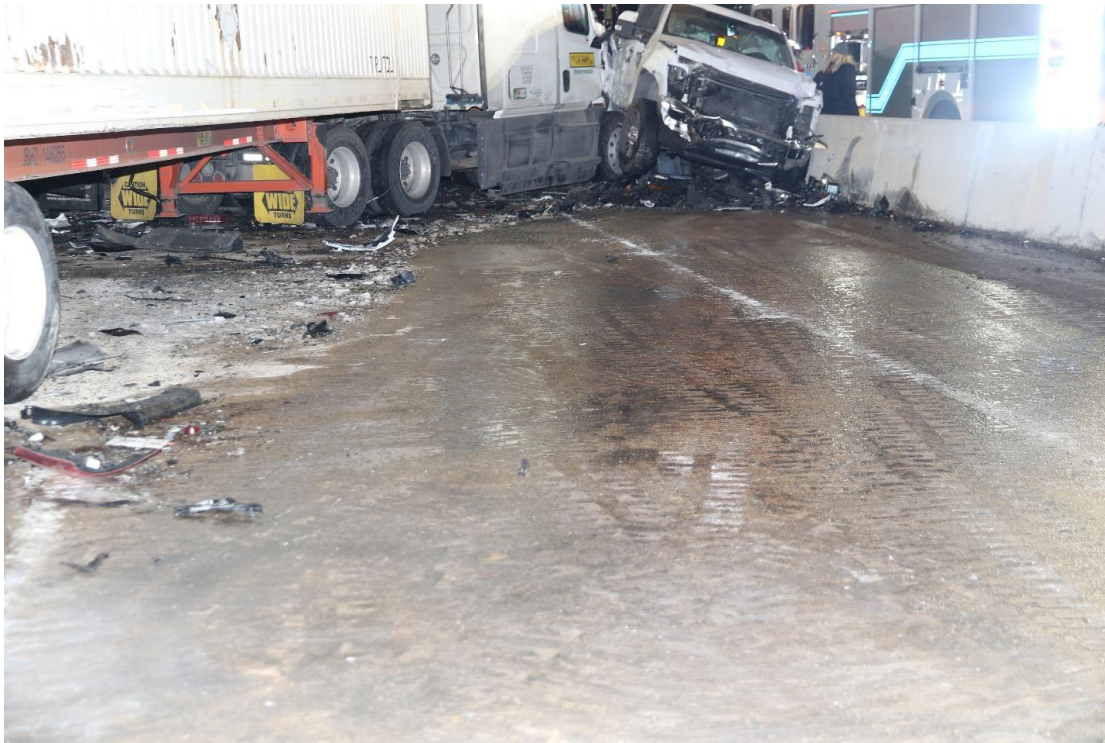
Highway Factors Photo 18 – View of damaged vehicles at the northern end of the I-35W southbound toll lanes crash scene standing on the right travel lane of the I-35W southbound toll lanes illustrating the ice on the roadway surface looking to the southwest (Source: Fort Worth Police Department. Photo taken on February 11, 2021, at approximately 6:27 p.m.)
