Highway Factors Photographs 1 through 18

Fort Worth, TX

HWY21FH005

Specialist's Factual Report By Kyle Garner

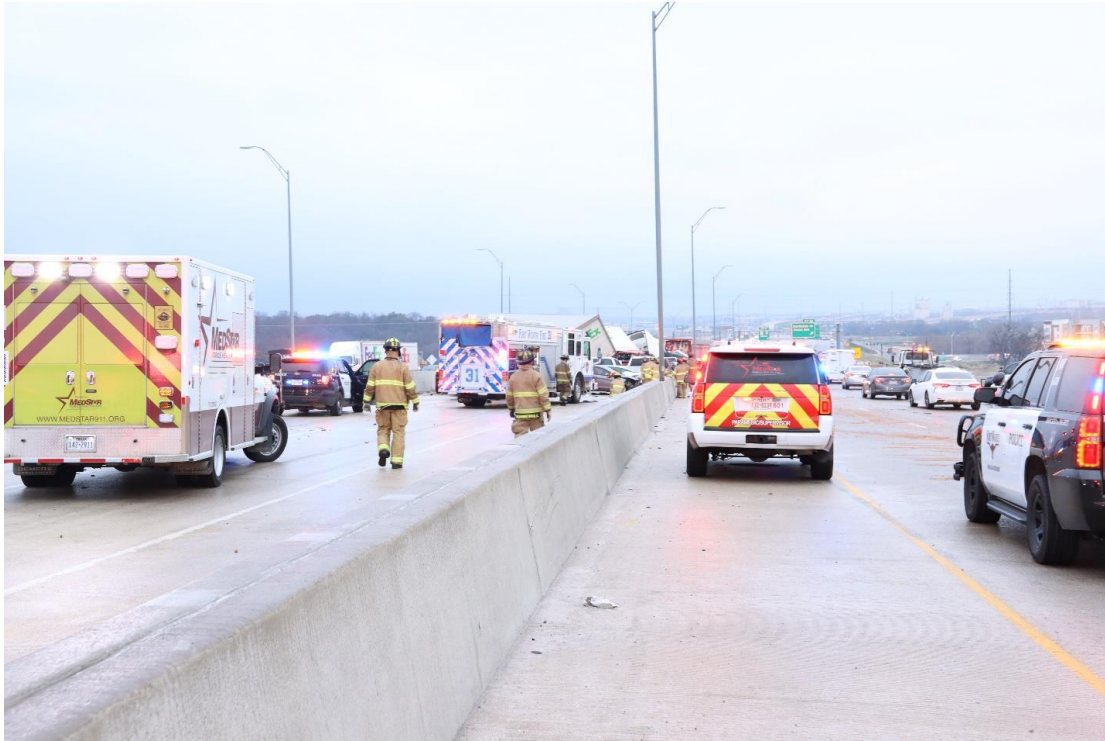
Highway Factors Photo 2 - View of northern end of the I-35W southbound toll lanes crash scene standing on the left paved shoulder of the I-35W southbound general use lanes looking to the south (Source: Fort Worth Police Department. Photo taken on February 11, 2021, at approximately 7:33 a.m.)

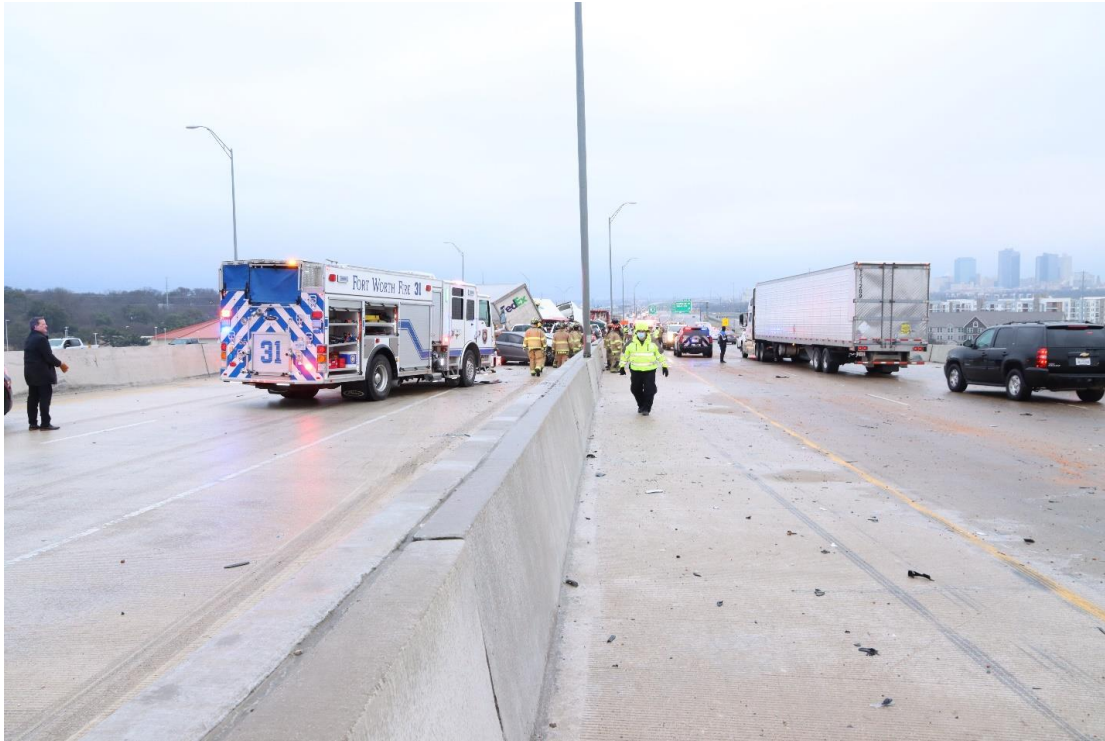
Highway Factors Photo 3 – Another view of northern end of the I-35W southbound toll lanes crash scene standing on the left paved shoulder of the I-35W southbound general use lanes looking to the south (Source: Fort Worth Police Department. Photo taken on February 11, 2021, at approximately 7:34 a.m.)

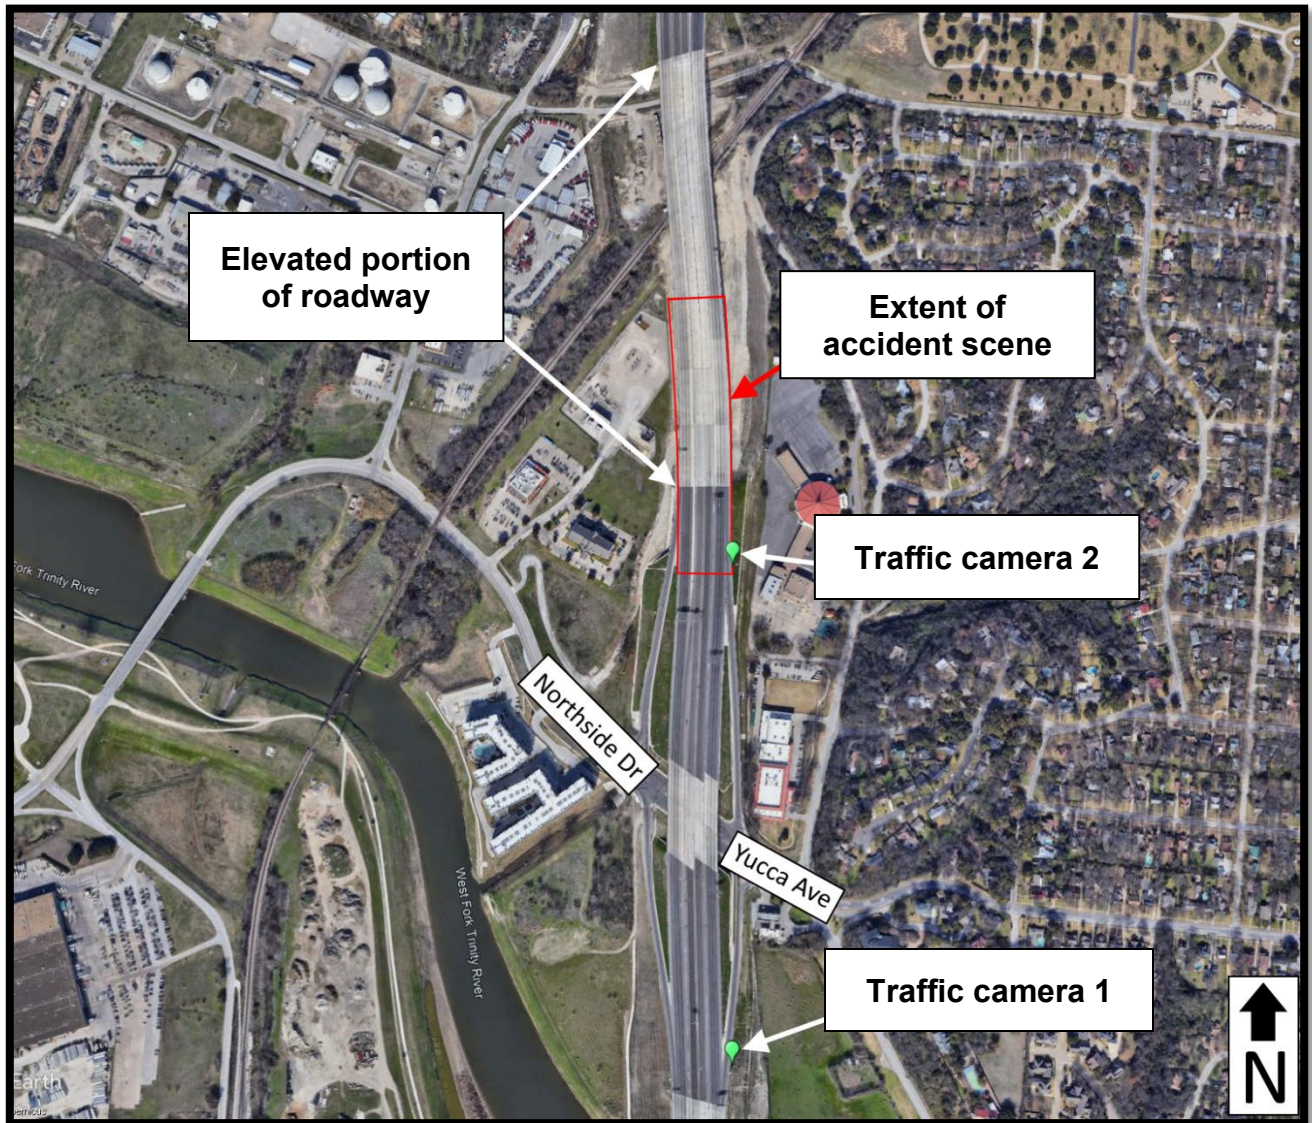
Figure 4 is a map showing the location of the traffic cameras and the extent of the crash scene. The elevated portion of the roadway is also noted for reference.

Figure 4. Traffic camera locations and extent of the accident scene⁶

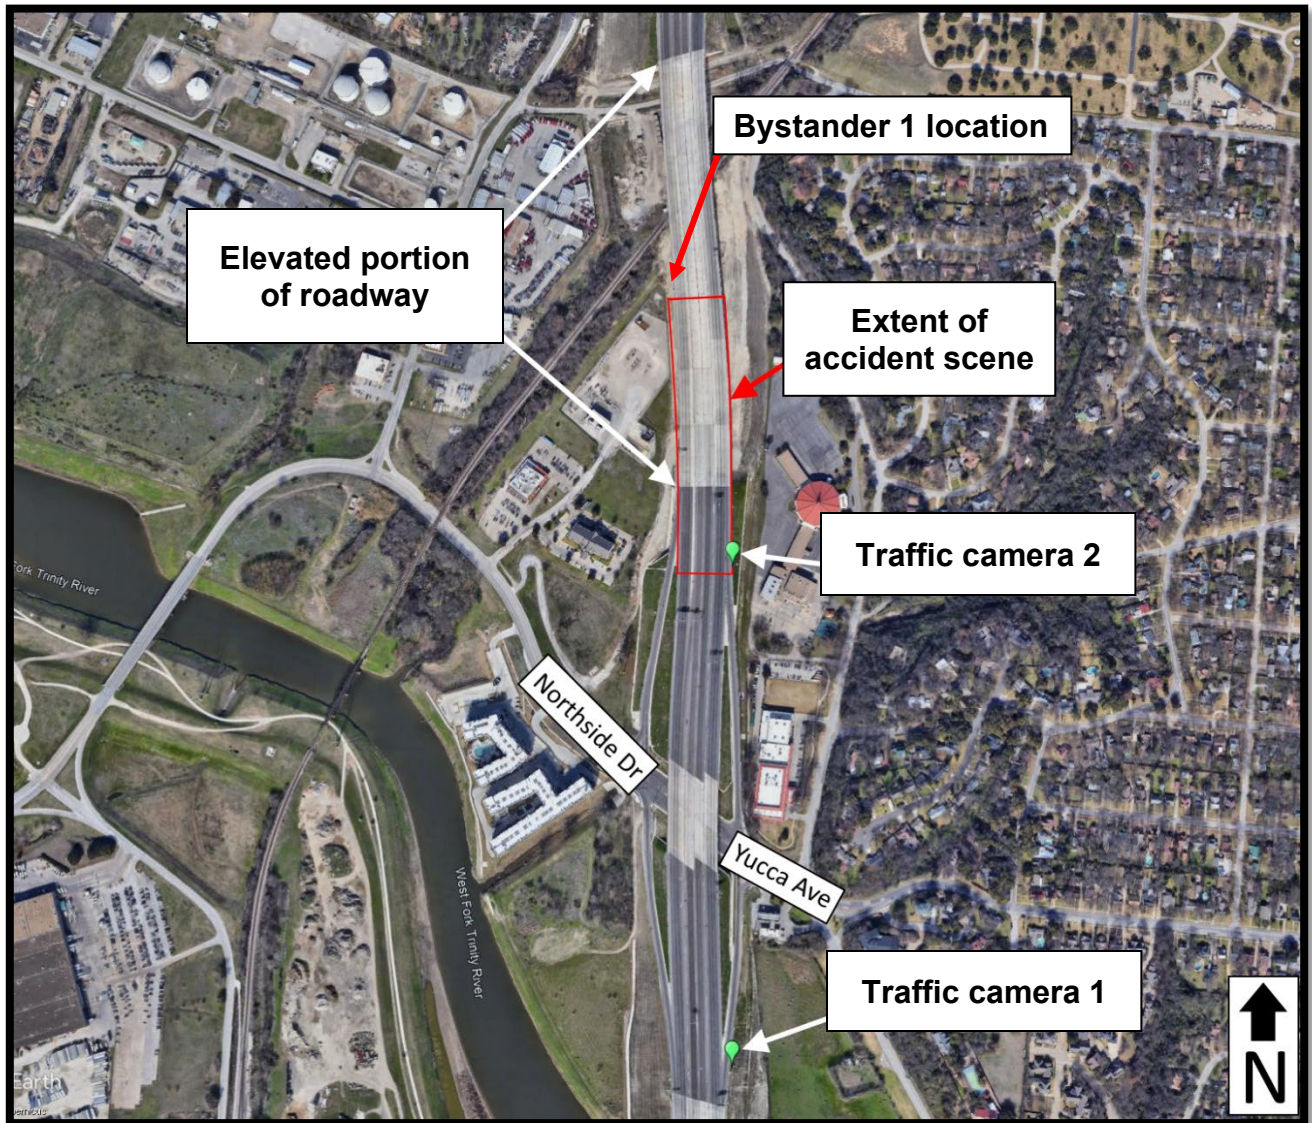
At the beginning of the video, bystander 1 was standing in the left shoulder of the SB general use lanes adjacent to a concrete barrier approximately 1/3 mile north of Northside Drive/Yucca Avenue (see Figure 6).

Figure 6. Location of the bystander¹⁶.
